THERMAL AGING OF SILVER-PLATED COPPER AIRCRAFT
ELECTRICAL WIRE

MAY 1973

AFML-TR-73-113

L. R. BIDWELL

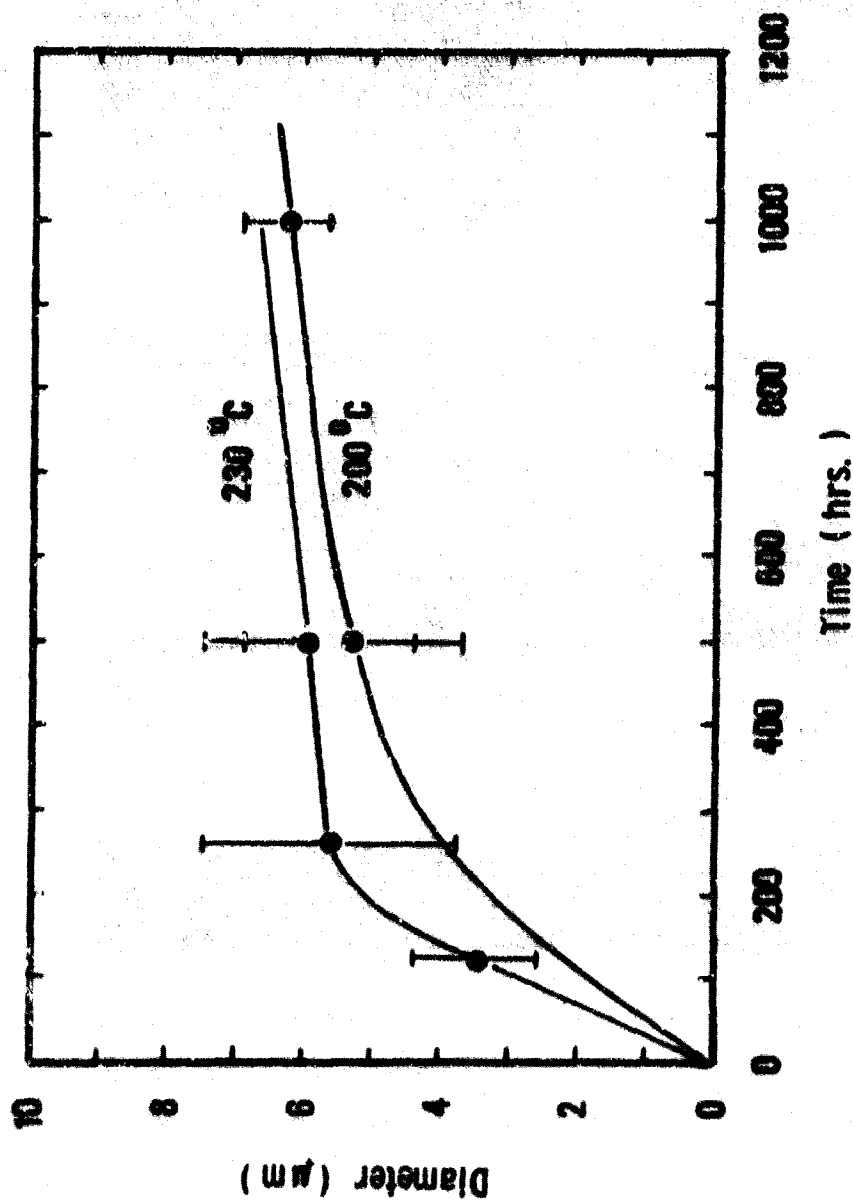
Figure 12. Diameter of larger silver globules on No. 20 (19/32) Rapton insulated unilay wire as a function of time and temperature.
